# Manhole Inspection Summary

Manhole # S33A\_\_045MH

**Location** Address: **515 CENTRE ST** Cross Street: **CATHEDRAL ST**

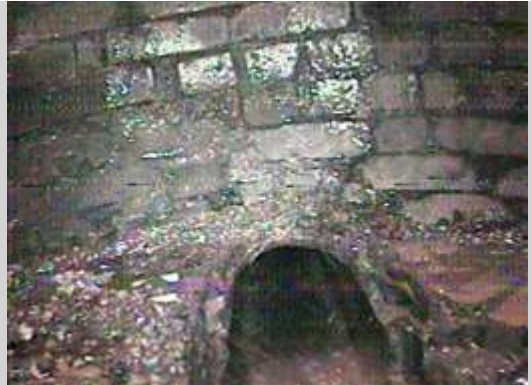
12 O'Clock Outflow

12 in. Circular Gravity Sewer  
Pipe Out @ 12 O'Clock

Pipe Height: **7.2** (in.) Rod and Bar  
Pipe Material: **Clay** ☐ Pipe Lined  
Invert Depth: **17.03** (ft.) Flow Characteristics: **Fast**  
Deposits: ☒ None ☐ Mud ☐ Sludge ☐ Debris ☐ Grease  
Silt Depth: (in.) Deposits Extent:  
Infiltration: **None** Pipe Seal Cond: **Sound**

Drop: **None**
